# Remedial measures in the event of water penetration, model 452

## Remedial measures, seals, model R/C 452

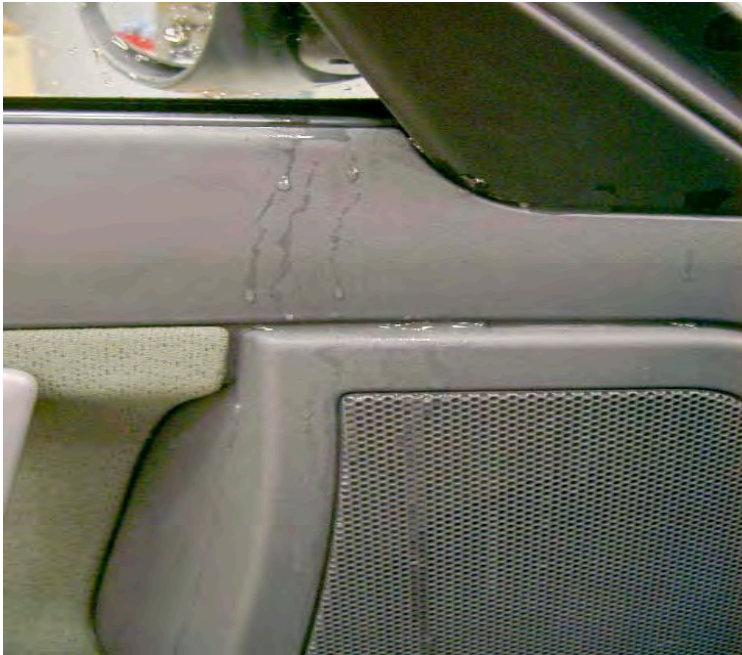
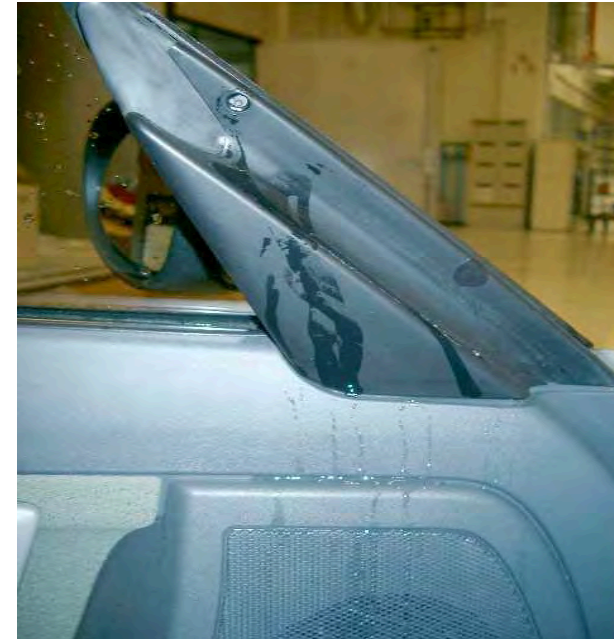
Effect figure 1. Water penetrating through door's inner liner/speaker and mirror mounting

**Note:** Drips which reach the inside of the vehicle via the inner liner must be reduced in volume to ensure that they are able to exit via the duct seal.

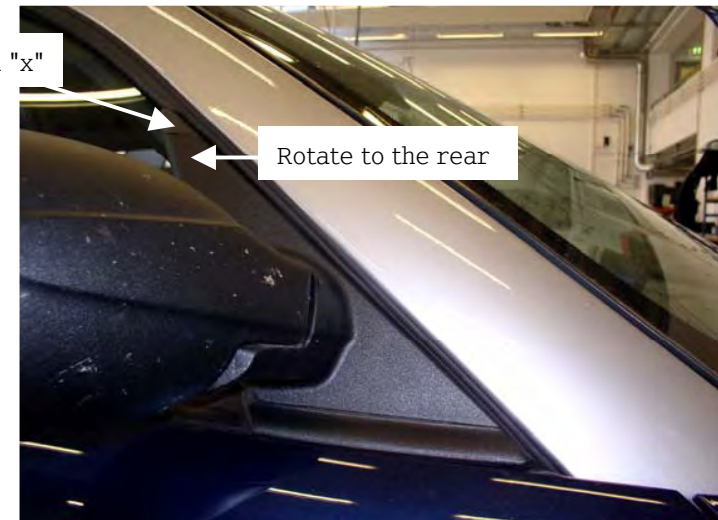
### Measure 1.2.

Contact in "z" and "x"

Rotate to the rear

**Optimise mirror mounting fitting:**

- Slacken the mirror mounting screw fastener and tilt the mirror back slightly so that the door does not compress the roof peak seal when closed. This ensures optimum tightness at the transition from the mirror to the roof peak seal.

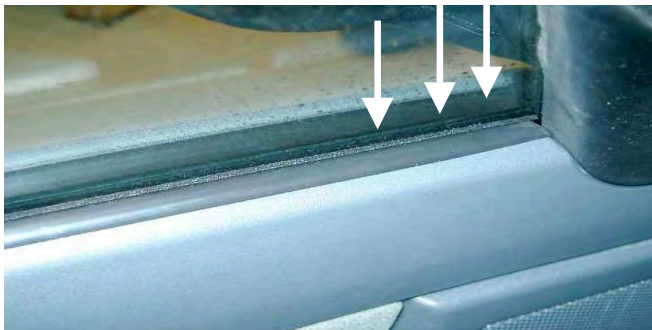
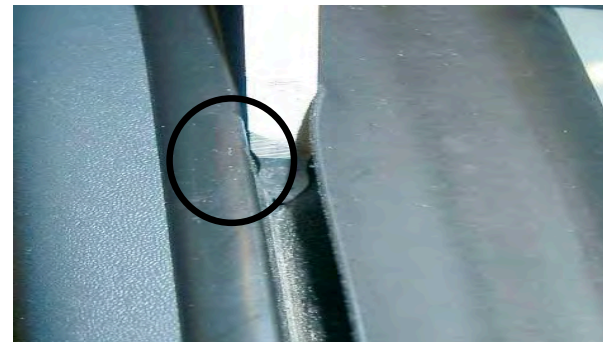
### Measure 1.5.

the water can no longer run through the inner duct seal of the side window.

- Check the drainage holes in the front and rear duct seals.
- The lip must not close the duct seal channel.

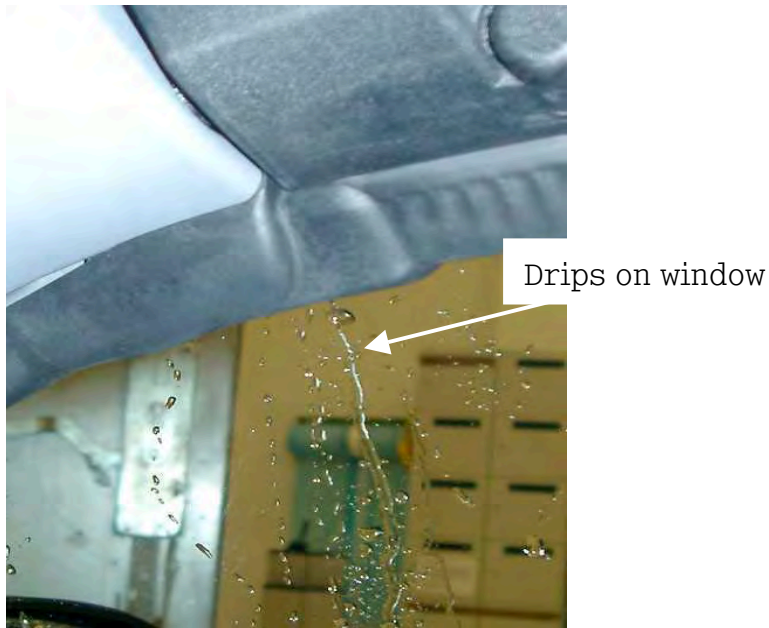
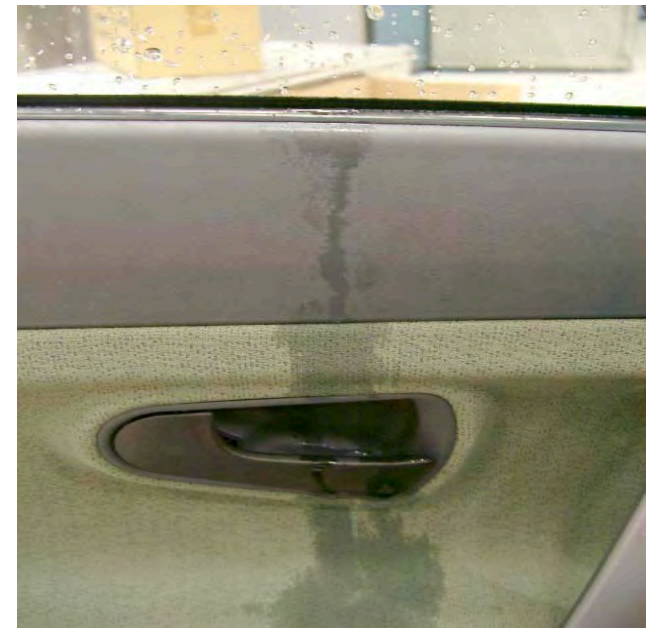
**Defect figure 2.** Water penetrates through centre of door liner - drips coming down the window from the joint between the roof peak/side spar

**Note:** Drips running down the window and into the vehicle interior via the inner liner must be reduced in volume to ensure that they are able to drain out through the duct seal.

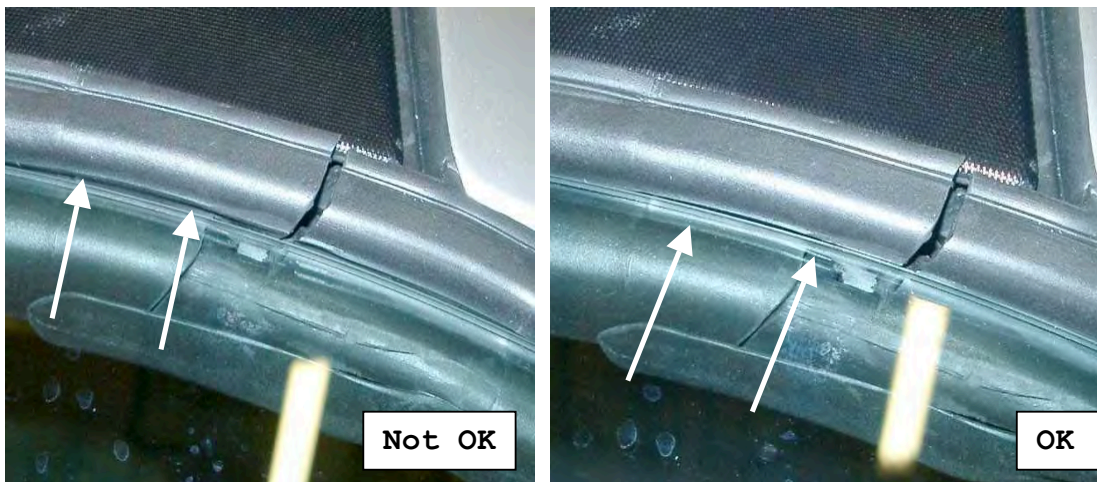
Figures Window adjustment screws

•Optimise side window position in Z and X axes until contact is ensured as shown in figure. Pull the lowering window max. 1.5 mm in the "Z" axis out of the retaining clip. If the adjustment is not sufficient, adjust the door on the hinge in the "Z" axis. The striker should also be adjusted to the door position.

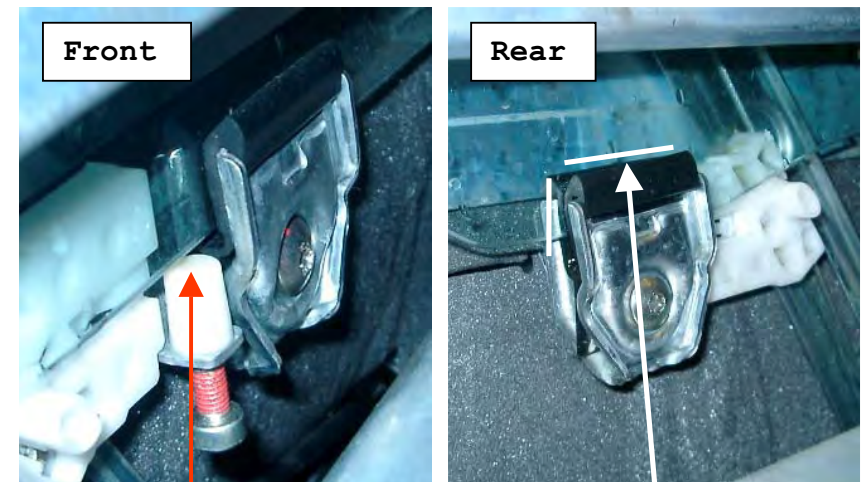
Window is not in contact "in Z" axis

Window in contact in "Z" axis

Readjust window stop

Mark position stop

**Standard:** The side window must not compress the seals when the door is closed.

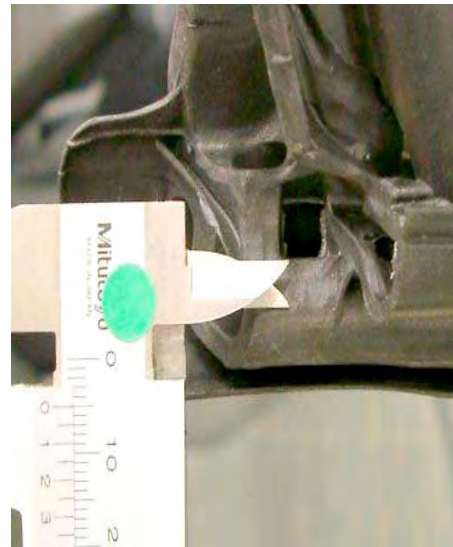
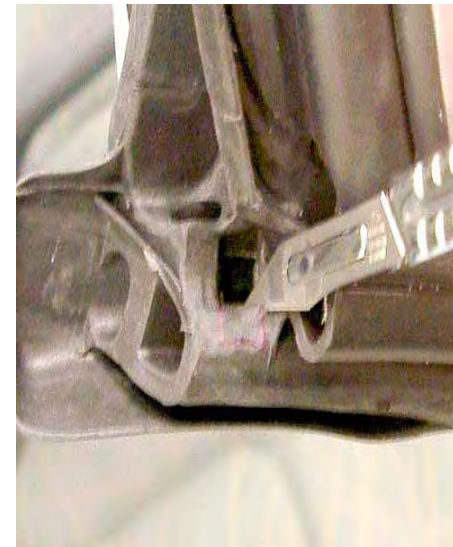
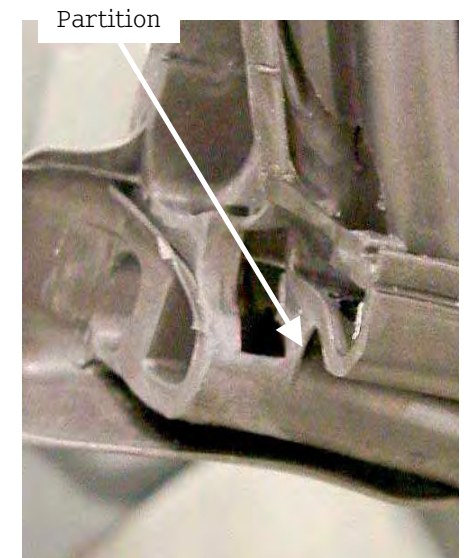
### Measure 2.3. Enlarge the roof peak seal drainage hole:

Before

After

Enlarge the hole in the seal by approx. 5mm using a scalpel.  
**Attention** : do not damage the partition.

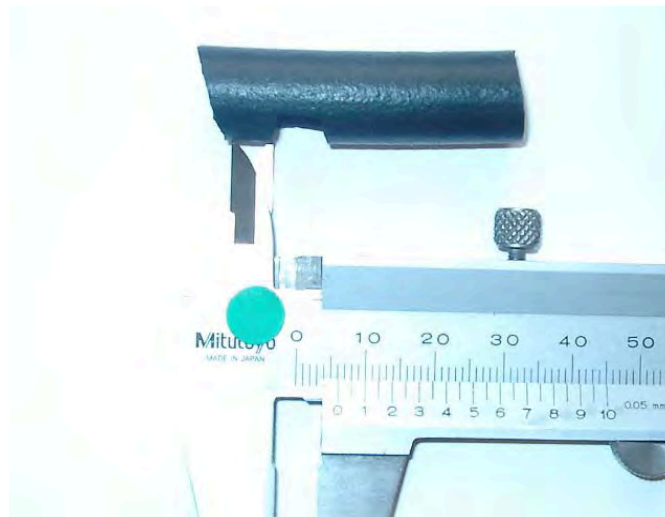
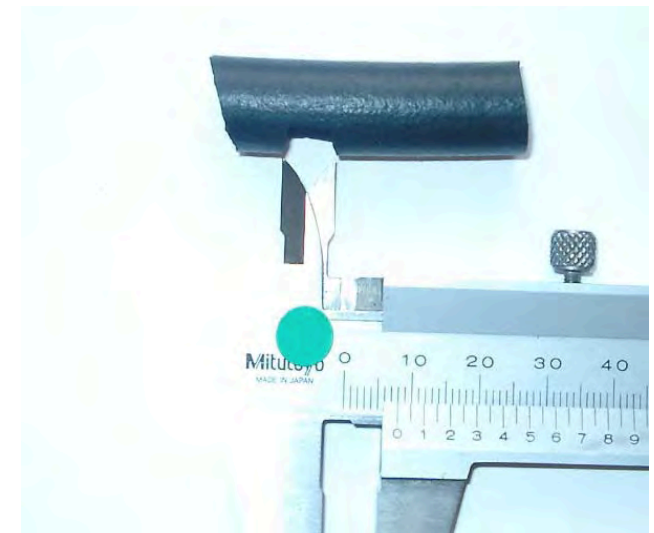
Measurements of cellular rubber hose

- Length = approx.40 mm
- Diameter = 13 mm x 3 mm wall thickness
- Notch from edge = approx.6 mm
- Notch width = approx.8 mm

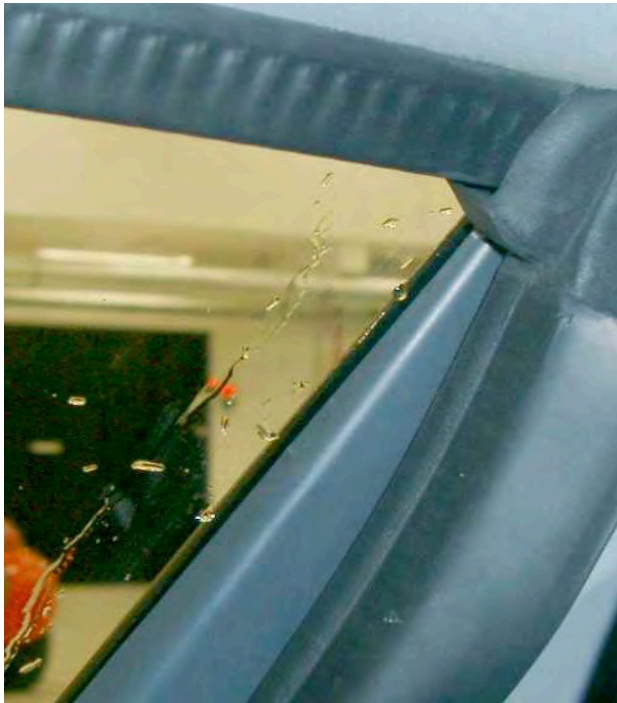
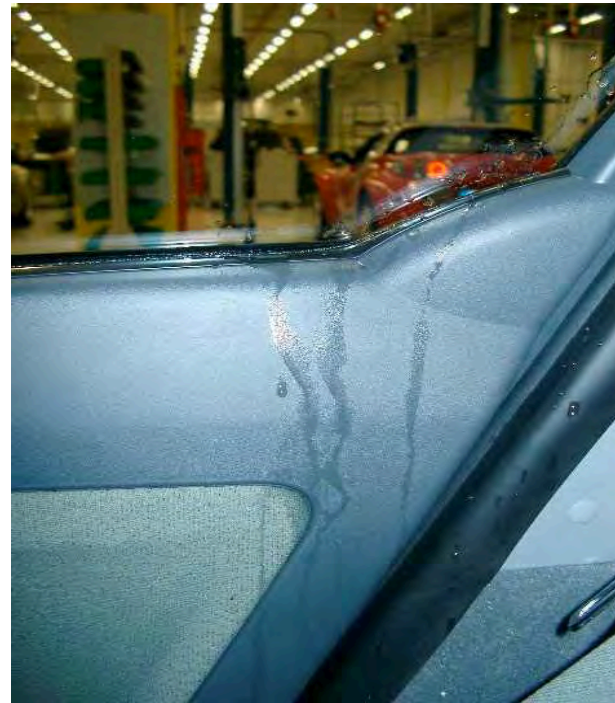
Defect figure 3. Water penetration via rear inner door liner / drips on window at rear

**Note:** Drips running down the window and into the vehicle interior via the inner liner must be reduced in volume to ensure that they are able to drain out through the duct seal.

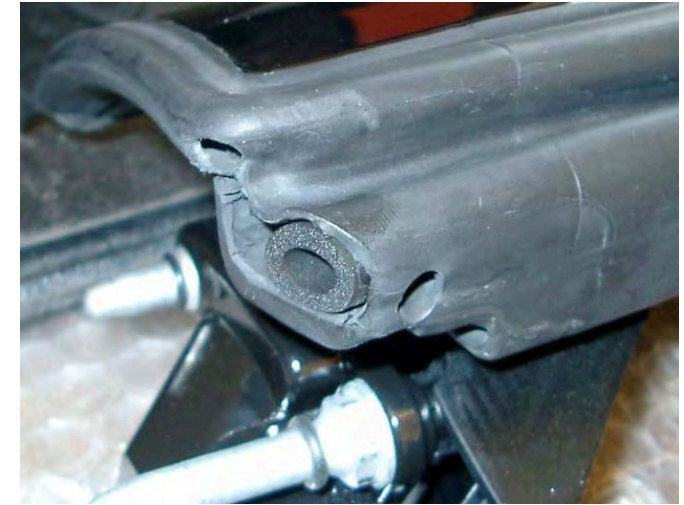
Drainage channel web width = 7 mm

Channel notch = 8 mm

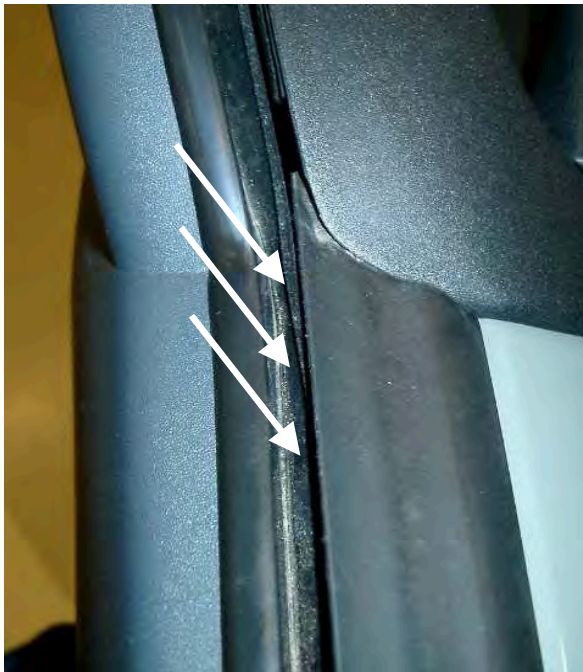
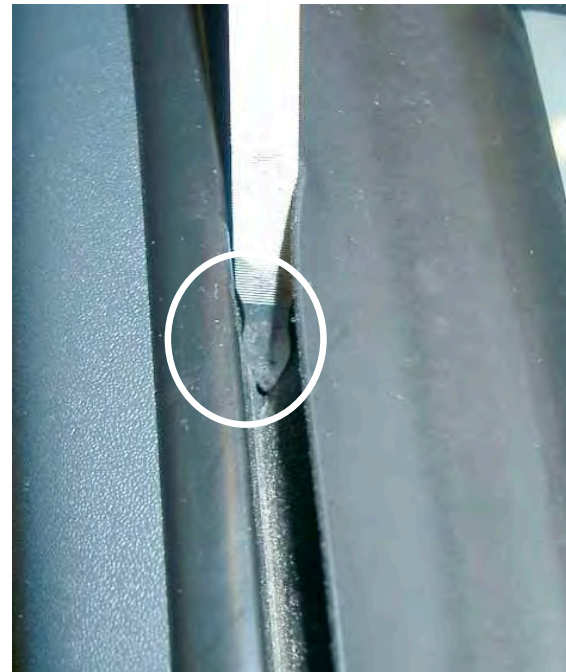
### Measure 3.3. Check the drainage holes in the duct seal:

#### **The water cannot drain through the inner duct seal of the side window:**

Check the drainage holes in the front and rear duct seals. Reposition the seal if necessary.

- The lip must not close the duct seal channel.

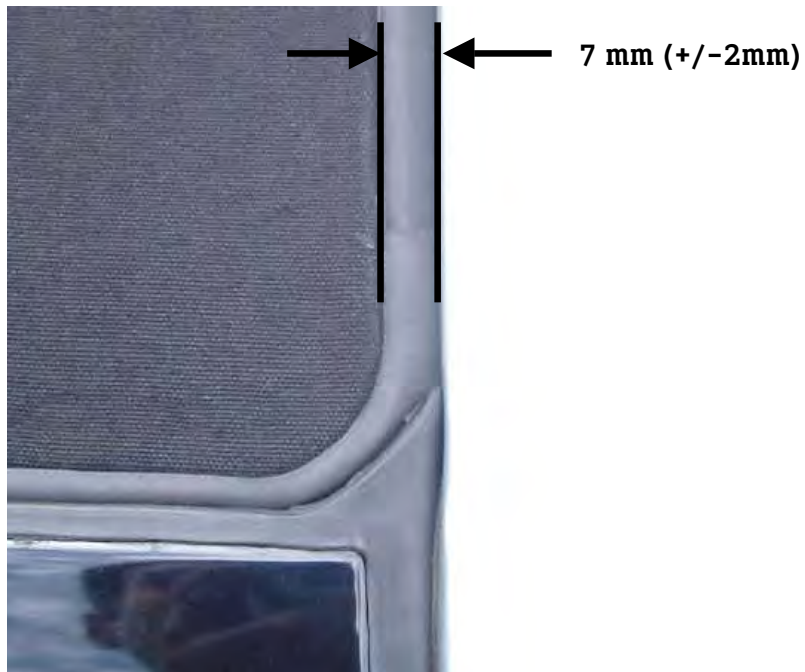
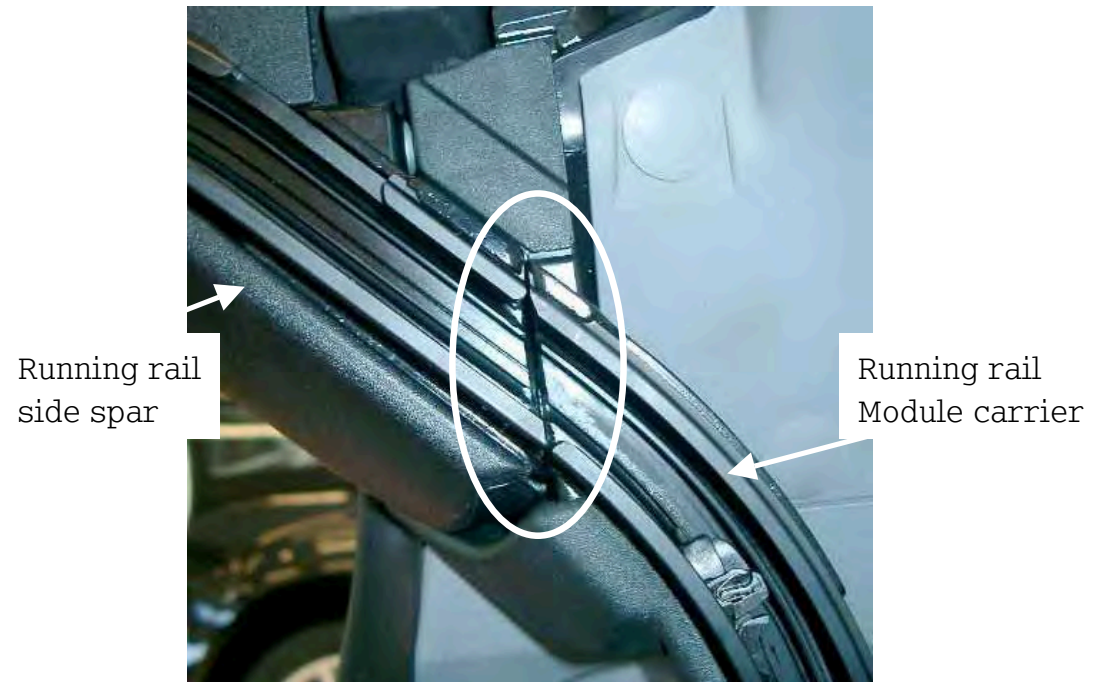
The joint between the canopy/hard top shell to the roll bar must be 7 mm in the X-axis (tolerance +/- 2mm). If this value lies outside the tolerance or if left and right differ significantly, the soft top must be adjusted at the supports (B-pillar).

**Attention:** note the gap/transition between the soft-top and the running rails (parallel, not distorted)!

#### **Preliminary measure: check roof position and adjust if necessary.**

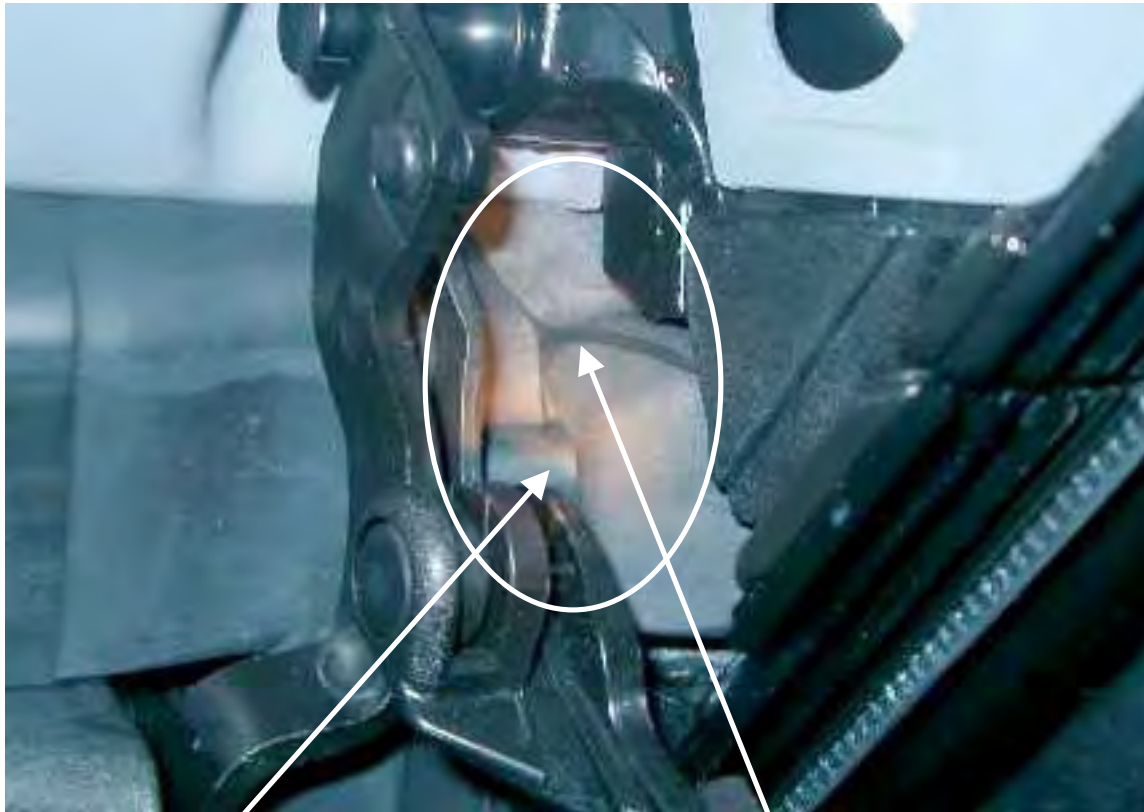
Canopy seal blow pipe, wasser exiting from canopy trough

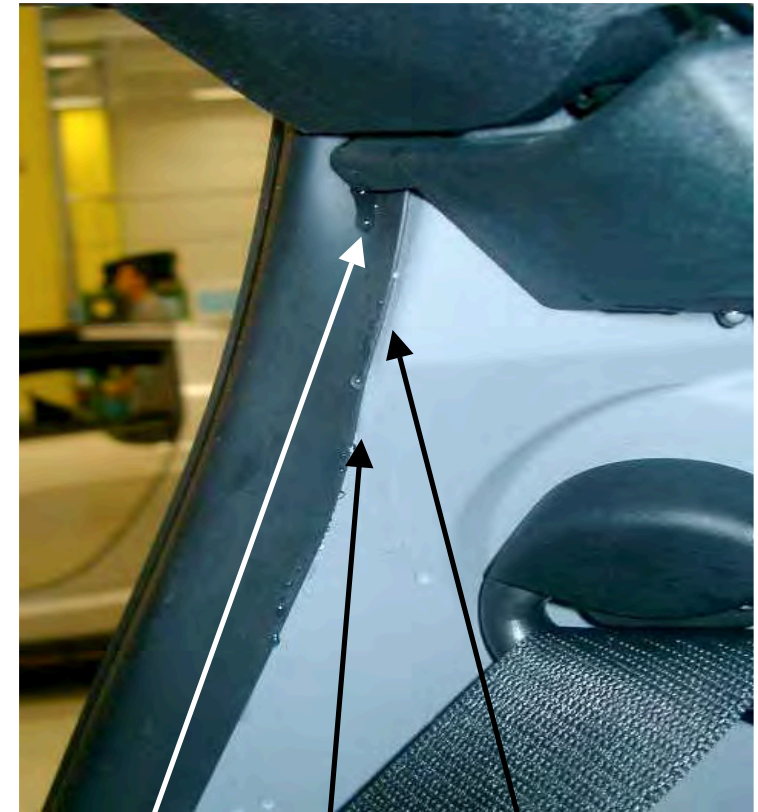
Water via inner liner

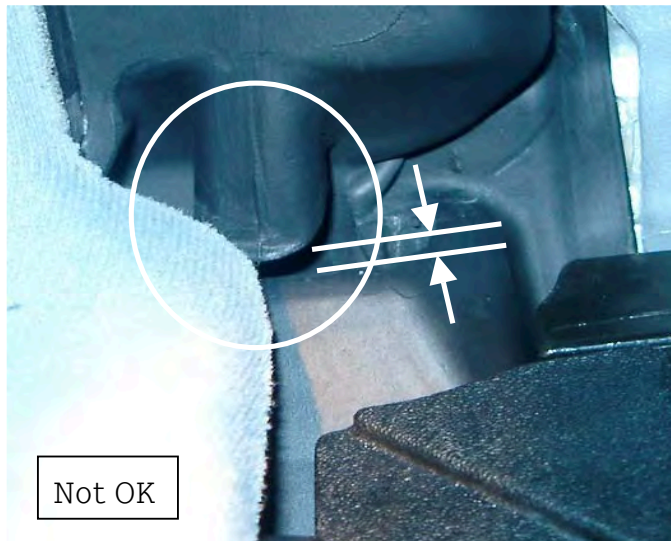
Photo from beneath  
(Example -hard top seal)

- The blow pipe must be positioned above the trough of the door seal.

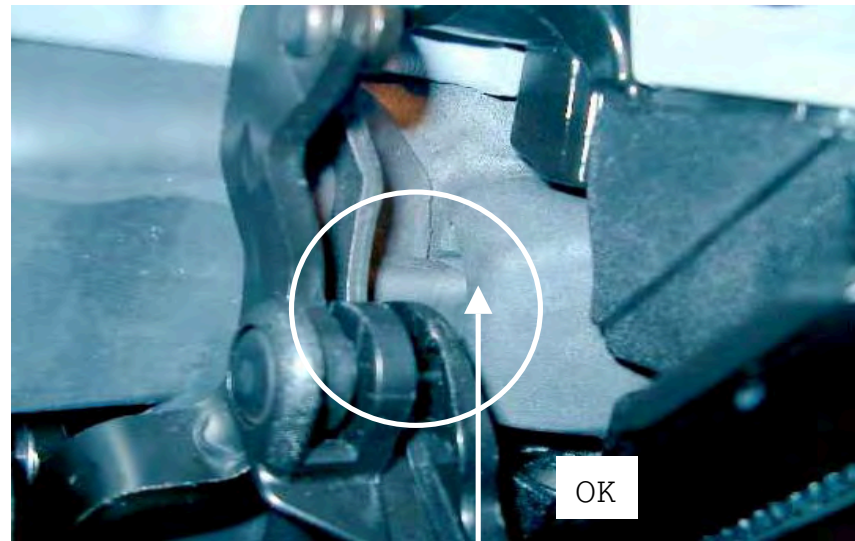
Blow pipe in door seal trough

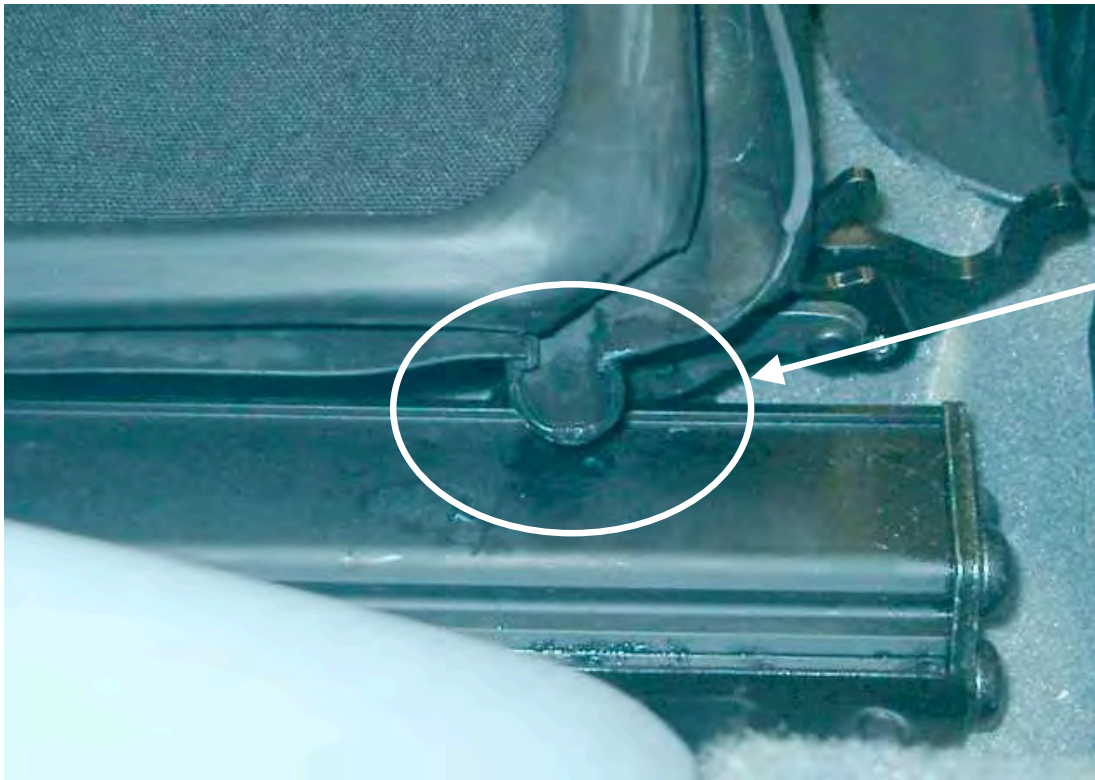
Water drops or moisture on the inside of the roof module carrier do not indicate a roof leak. When the soft top is opened after rain, water collected there can drip over the edge of the **canopy seal.**

To prevent drips forming below the blow pipe, treat inside and underside of the blow pipes with grease, item no. 0017777V001000000.

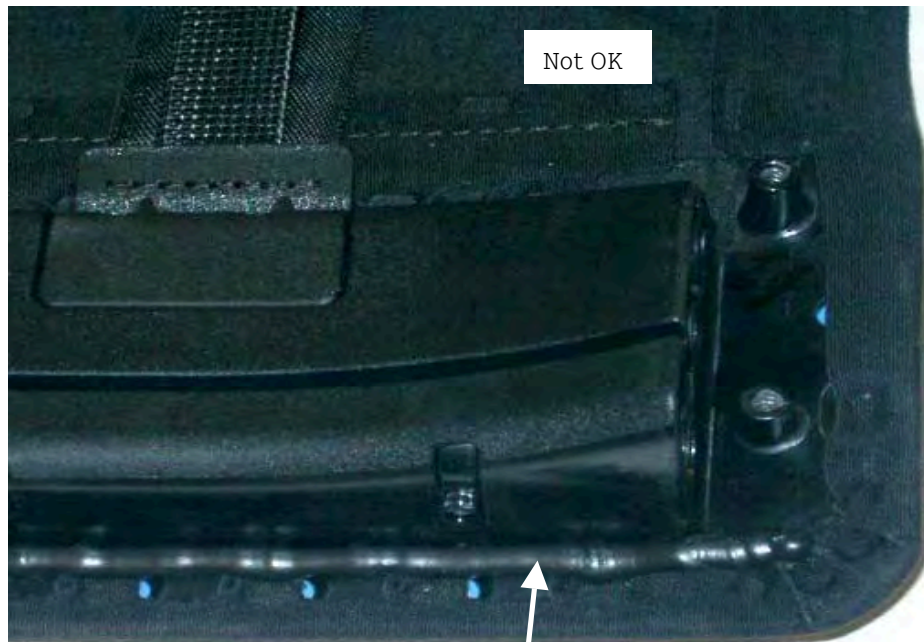
Sealant application, old

- Remove canopy seal and replace sealant application ( flexible window sealant) according to the figure.

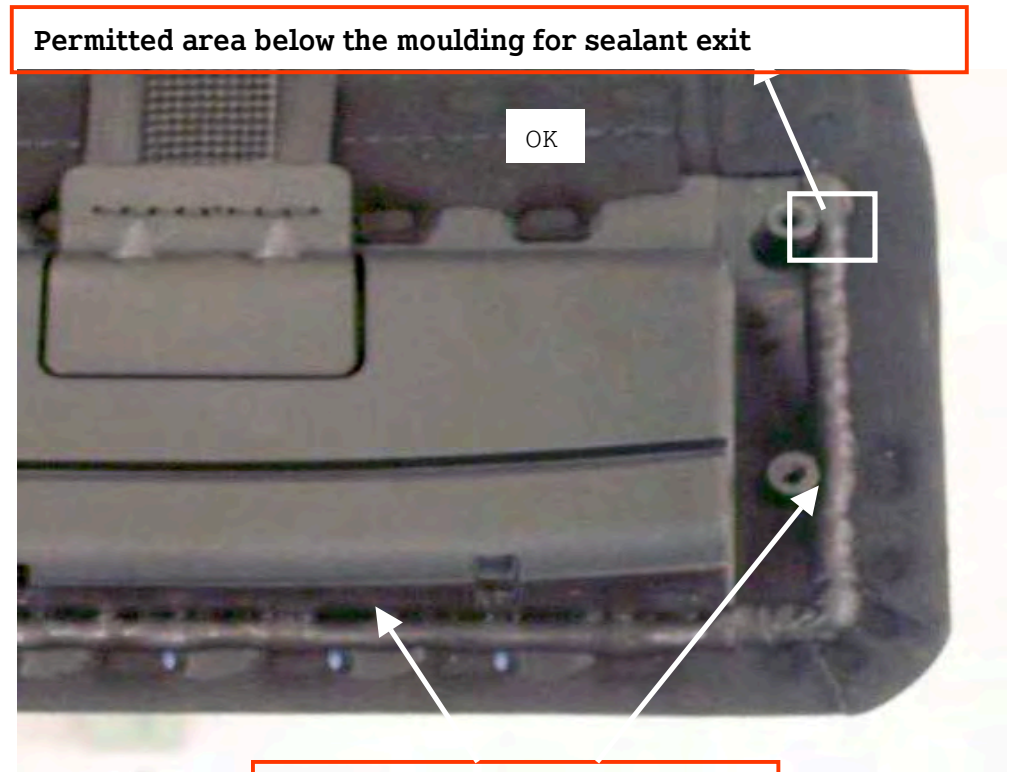
Sealant application, current

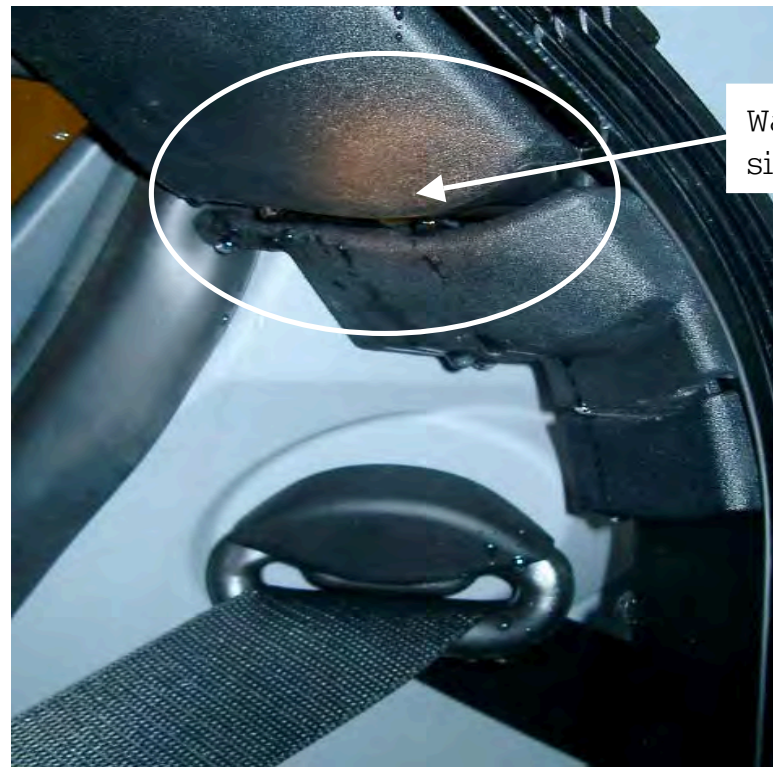
Water penetration between side spar and head pad

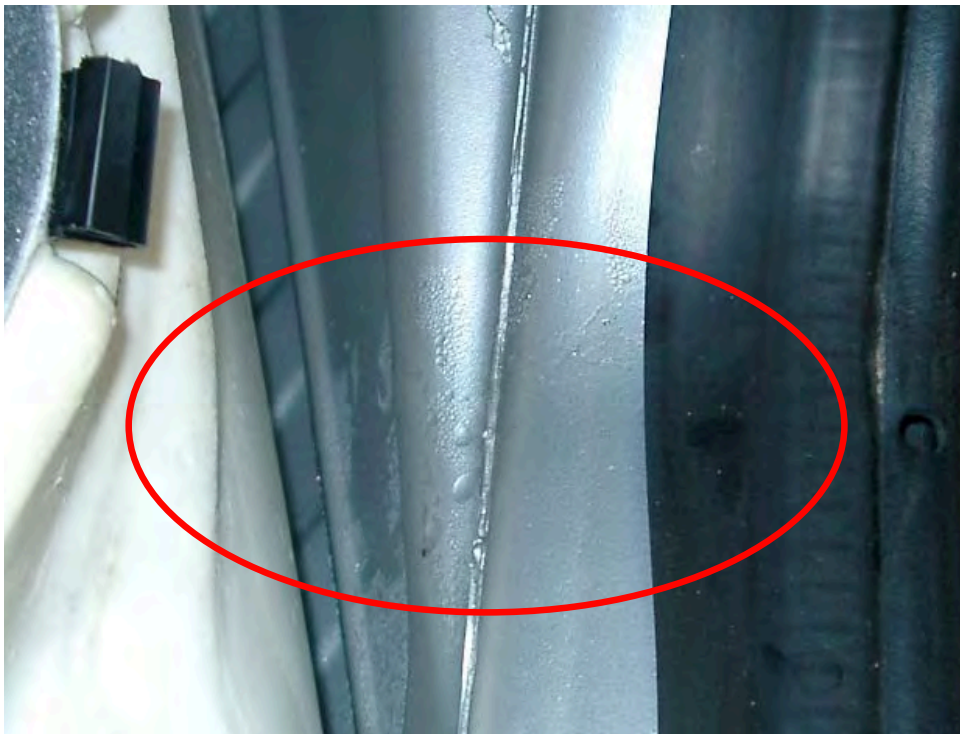
Water running over the sill into the floor area because the water changes sides in the seal's weather strip.
