# Remedial measures in the event of water penetration, model 452

## Remedial measures, seals, model R/C 452

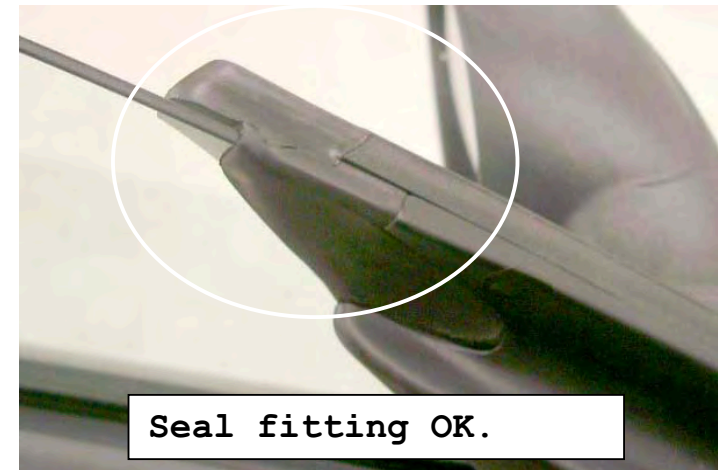
**Check the mirror mounting seal fitting and optimise if necessary:**

- Slacken the inside of the mirror mounting and reposition the seal.

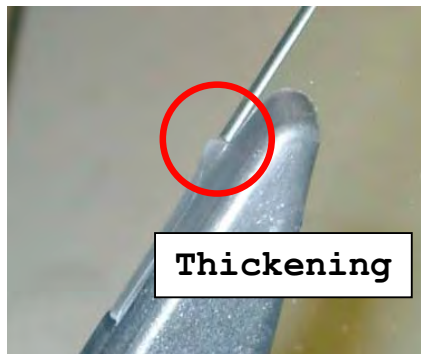
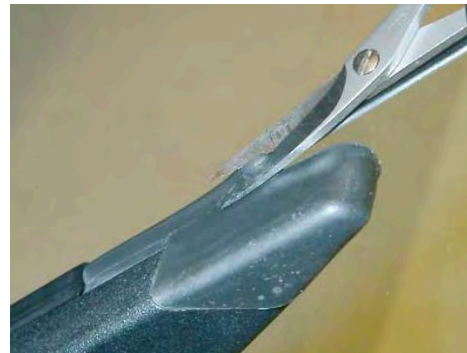
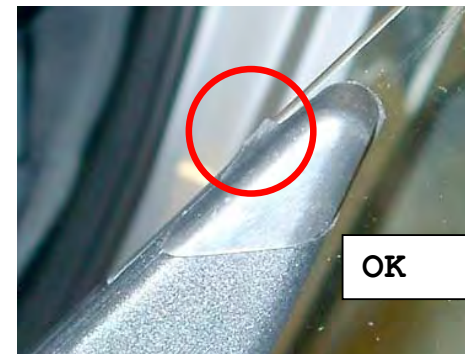
### Measure 1.4.

**IMPORTANT:** if the mirror mounting seal is raised by the repositioning of the side mirror it is necessary to address this problem. (See figures)

#### **Adjust mirror mounting seal:**

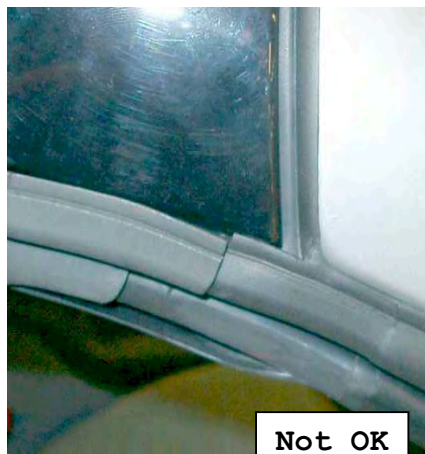
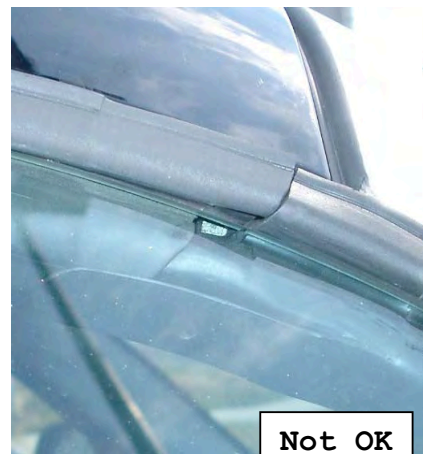
### Measure 2.1. Optimise the fitting of the seal:

Seals in contact with one another and compressing

- Slacken the roof peak seal, push the weatherstrips together by hand and fit according to the figures.
- Once the roof peak seal is removed from the body, check the sealer application in the seal and fill up if necessary. If there is sufficient sealer, it will adhere to the body flange. (See page 36)

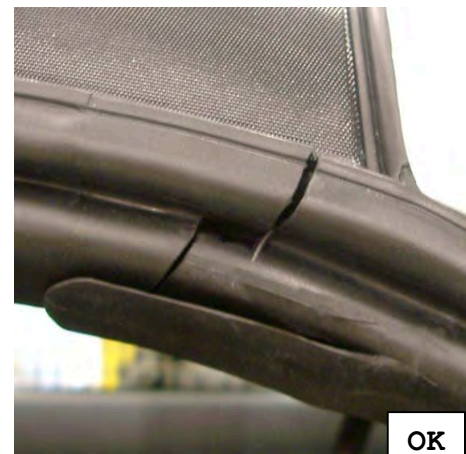
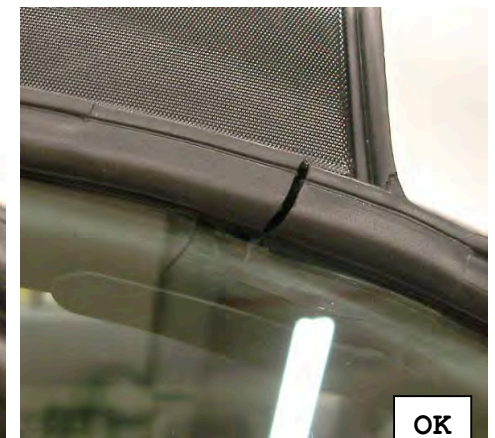
The seals sit flush side by side,  
Width of joint approx. 1 - 1.5mm

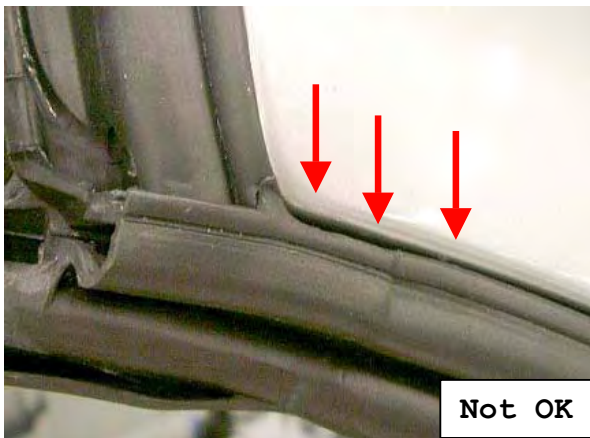
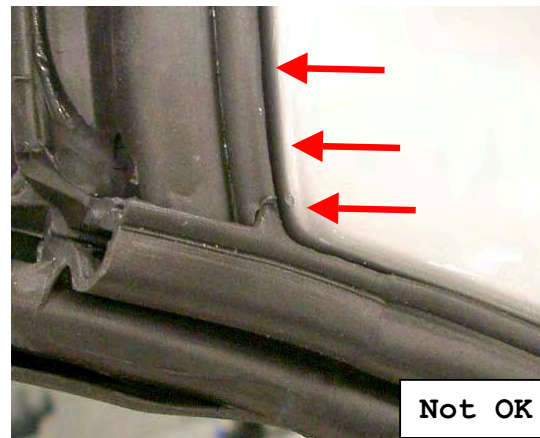
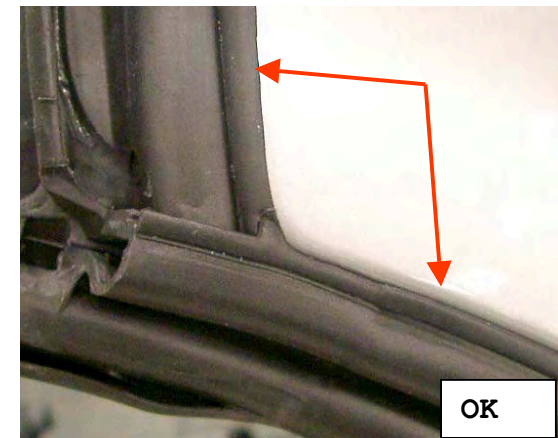
### Measure 2.1.

Roof peak seal is not in contact with the body shell

There must be no gaps between the seal and the the body shell at the radius.  
Figure OK

- Slacken the roof peak seal, push the weatherstrips together by hand and fit according to the figures.

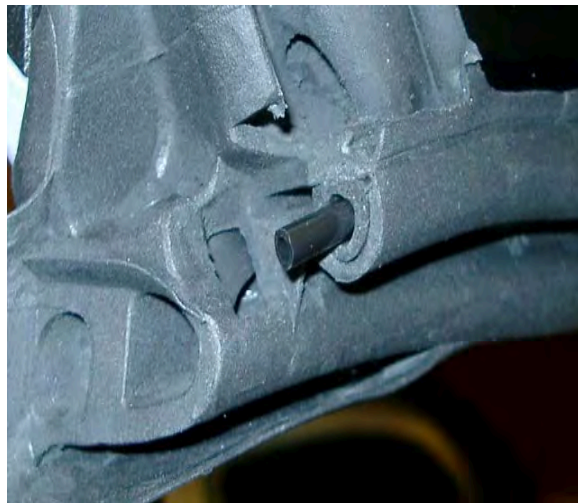
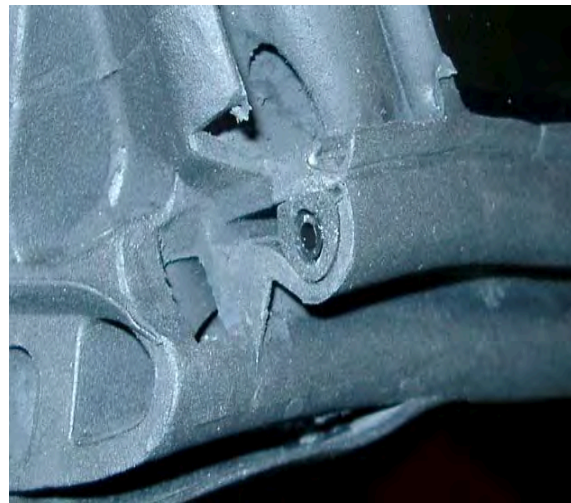
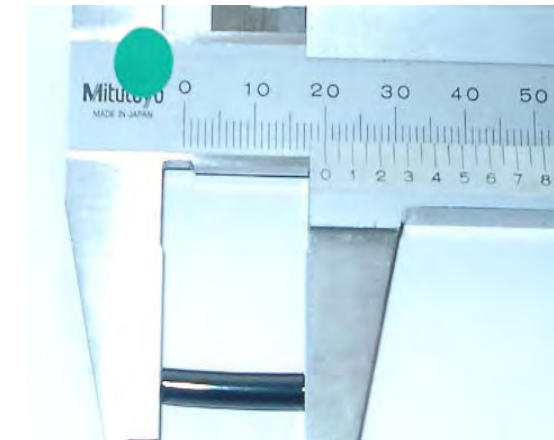
### Measure 2.4. Rework roof peak seal:

- The cellular rubber hose is already fitted during series production and a Festo air line is inserted for stabilisation.

- Pull Festo hose into roof peak seal hose insert and fix with Cyberbond 2241
- Festo hose length approx. 20mm.

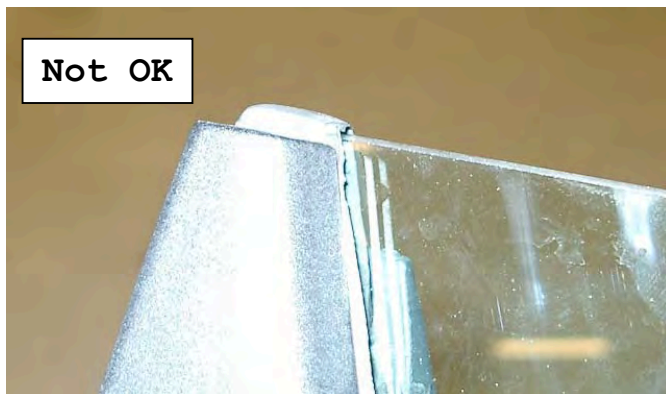
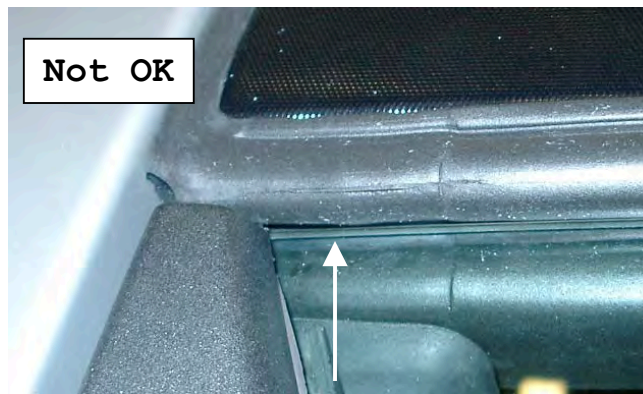
Before

Gap from window to seal too large

Pull the lowering window max. 1.5 mm out of the retaining clip in the "Z" axis. If the gap is too large the entire door must be raised in the "Z" axis. Use the door-side hinge screws to raise the door in the "Z" axis.

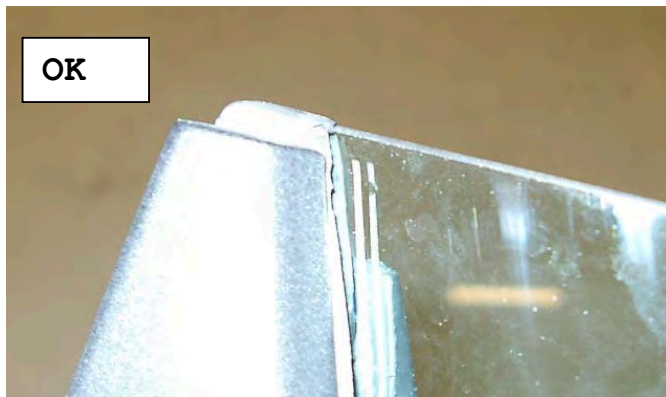
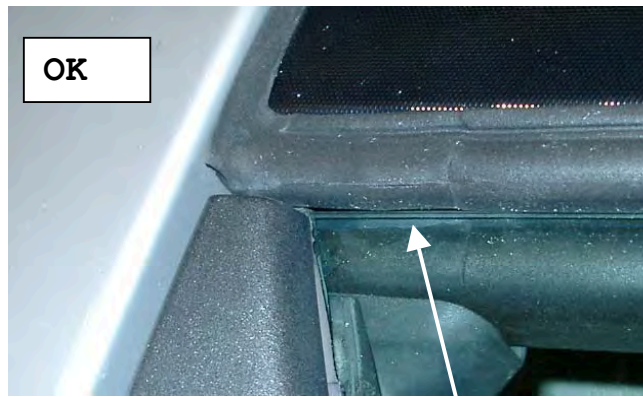
OK

Gap minimised by window adjustment:  
< 1mm

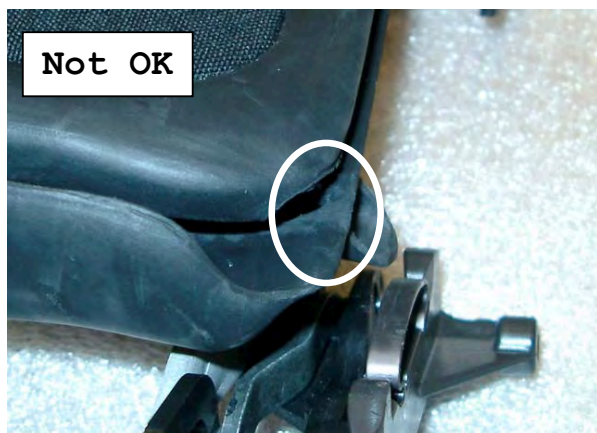
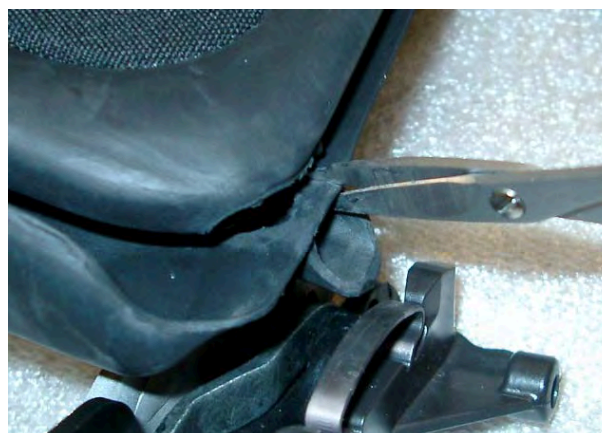
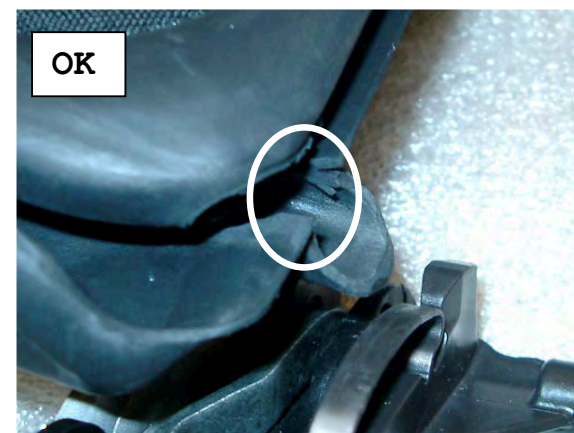
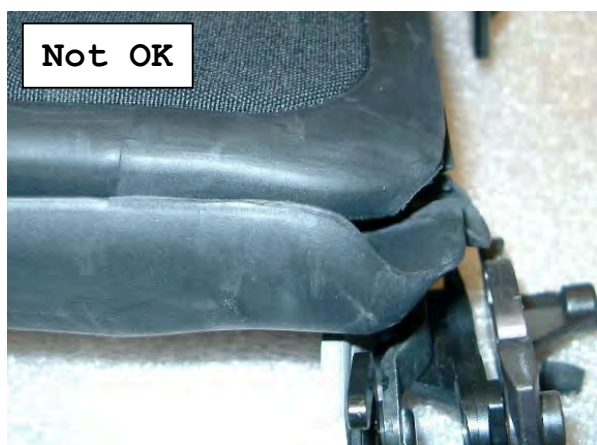
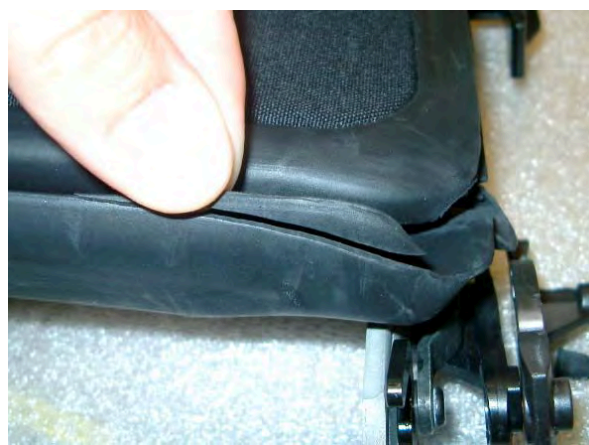
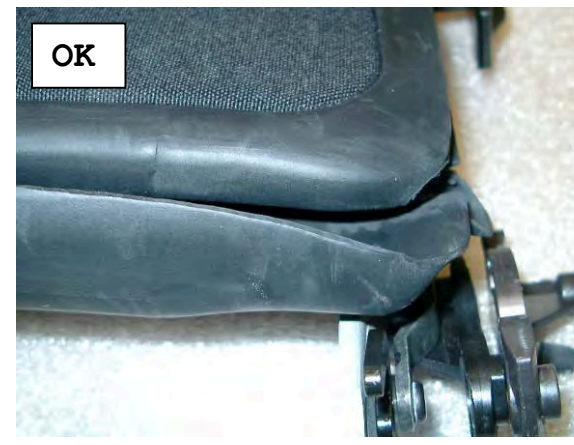
### Measure 4.1.3.

### Defect figure 4. Water penetration, B-pillar

Rework canopy seal (if not yet carried out)

To prevent drips forming below the blow pipe, treat inside and underside of the blow pipes with grease, item no. 0017777V001000000.

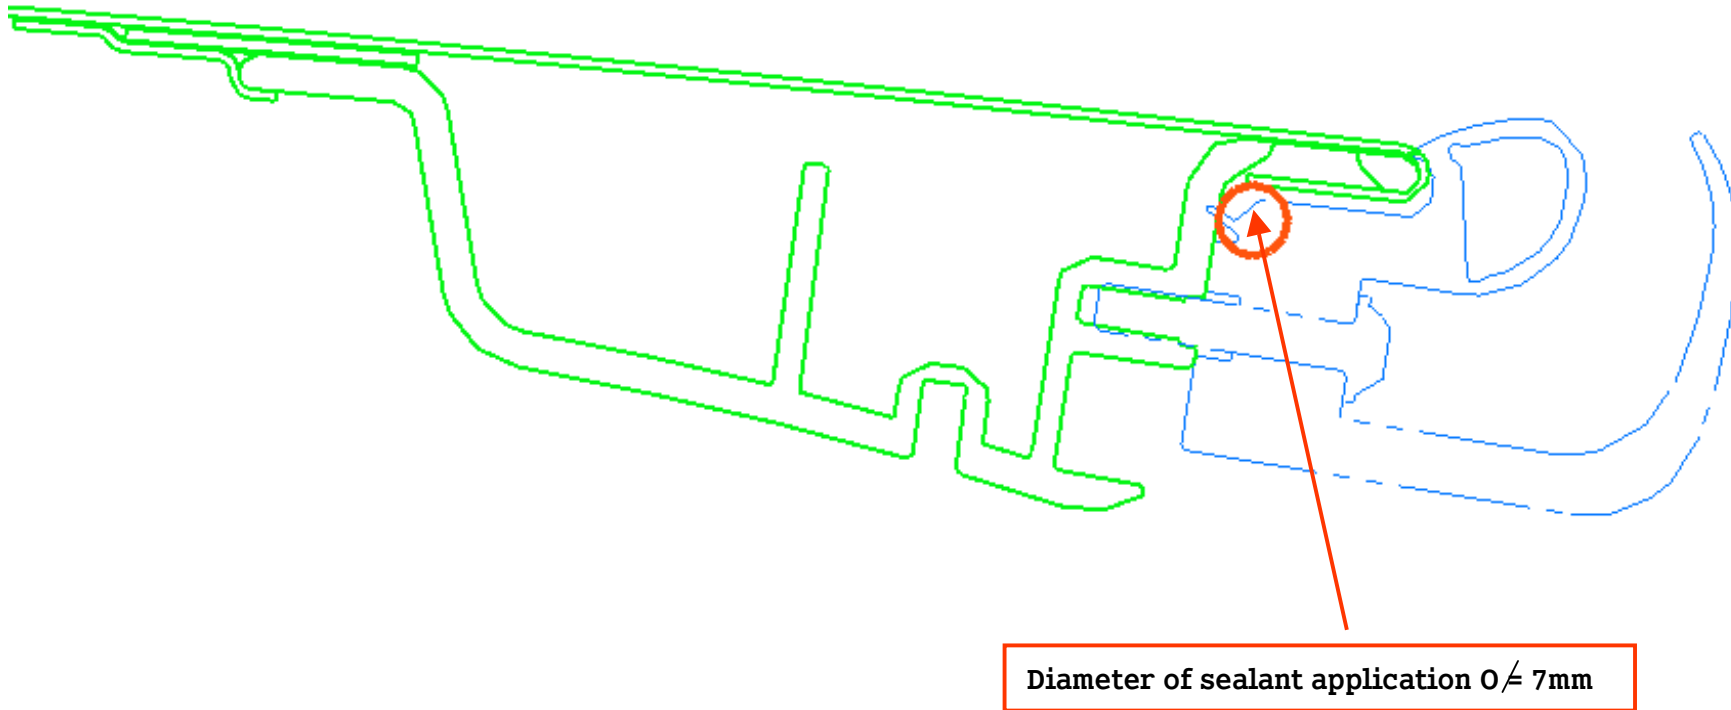
Measure 4.1.3. Rework sealant application on canopy seal:

Defect figure 4. Water penetration, B-pillar

- Remove canopy seal and replace sealant application ( flexible window sealant) according to the figure.

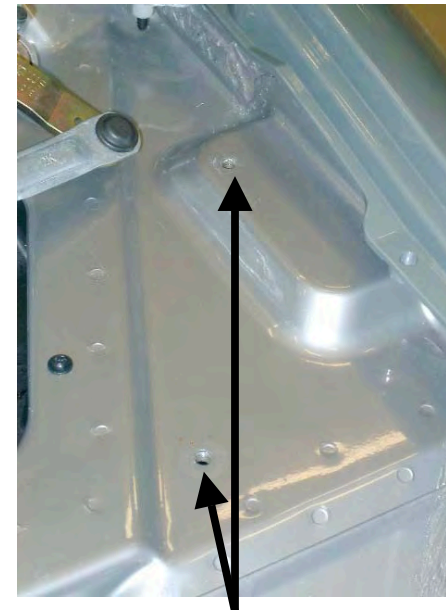
Side wall area below FLA right/left

### Defect figure 5 Water penetration in the floor area

Fastening screws -  
seal
